**MM&T FIBER-REINFORCED PLASTIC HELICOPTER TAIL
ROTOR ASSEMBLY (PULTRUDED SPAR)**

Maron J. Bonassar and John J. Lucas
Sikorsky Aircraft Division
United Technologies Corporation
Stratford, Conn. 06602

January 1980

Final Report for Period August 1975 - October 1978

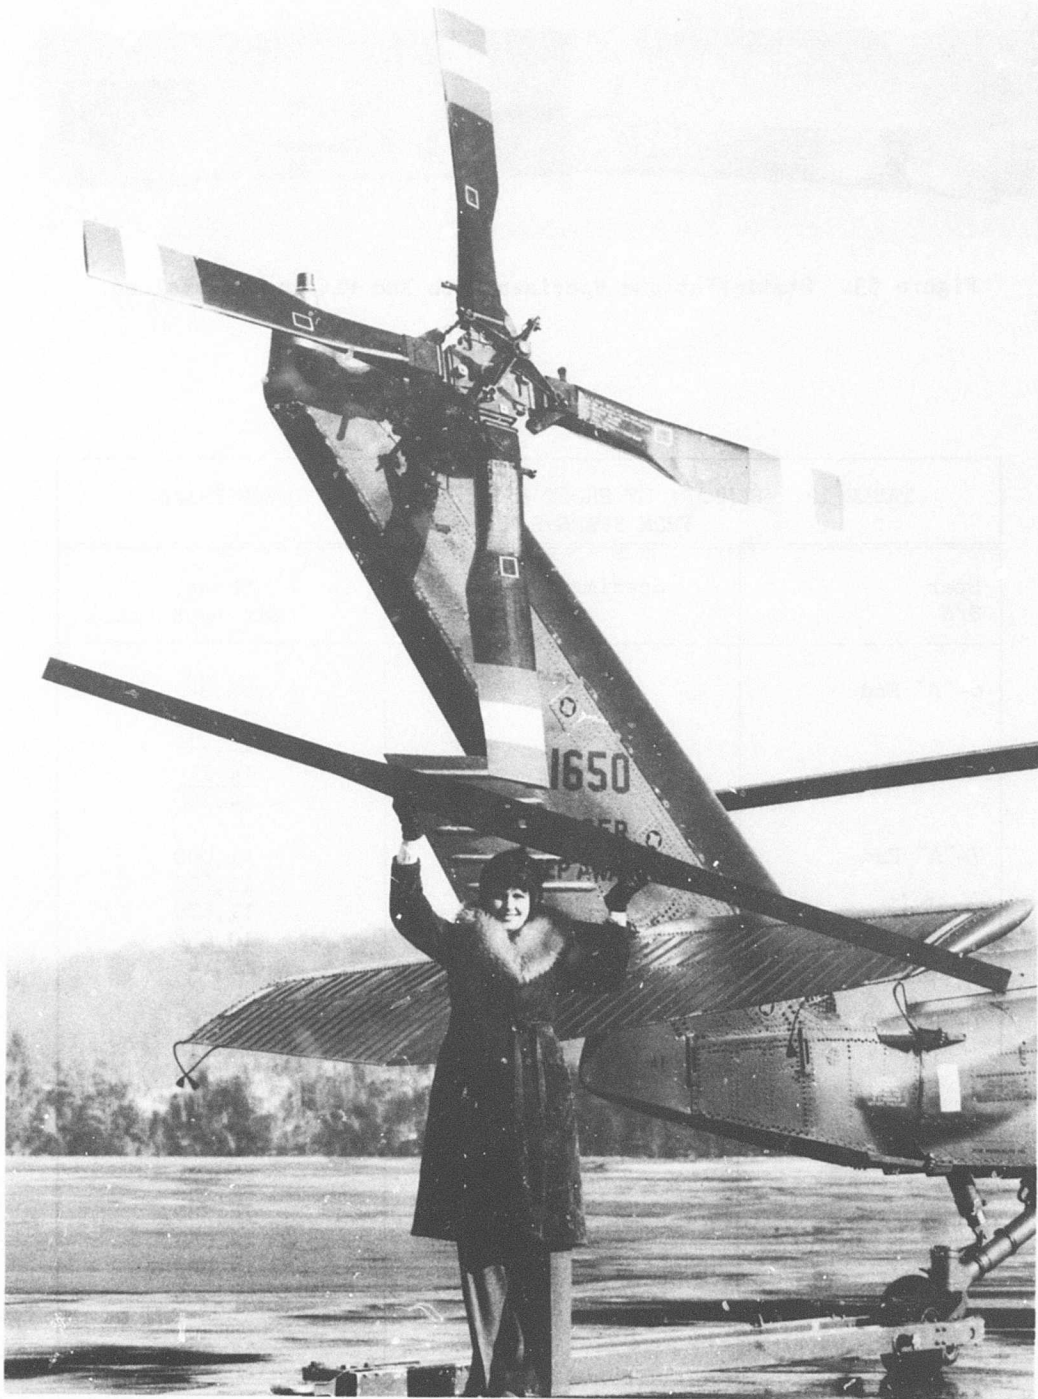
Figure 52. Full-Size Pultruded Tail Rotor Spar.

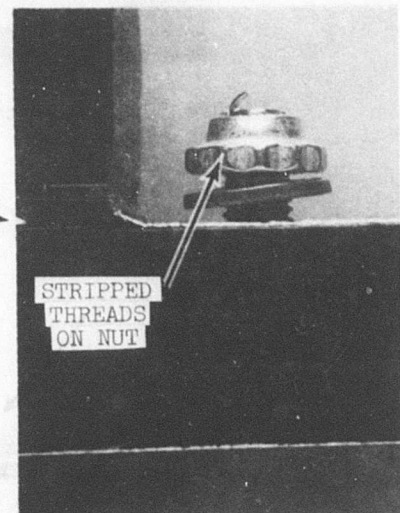
Figure 63. Closeup of Failed Area, Tip Attachment Static Retest Specimen. (2X)

(Note that failure mode is different than original)
